Inspection Report

Large New Home Inspection

123 Estate Lane
Charlotte, NC

Inspector Paul, Inc

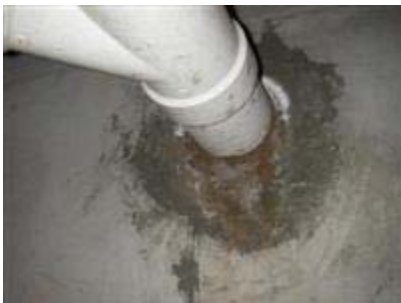
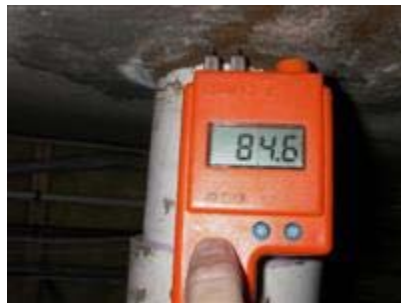
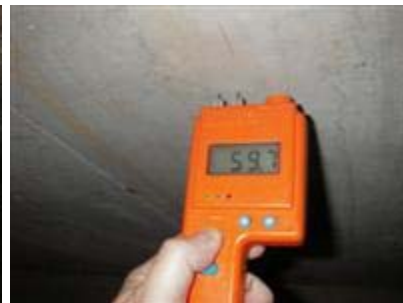
1.1 Evidence suggests there is a water intrusion problem where the sewer line passes through the foundation wall. The area was water stained, visibly wet, and the relative moisture content of the wall was 84.6% (the wall nearby was 59.7%). Water intrusion can lead to many costly problems if not corrected. Recommend further evaluation and repair as needed by a qualified licensed general contractor.

Evidence suggests there is a water intrusion problem where the sewer line passes through the foundation wall. The area was water stained, visibly wet, and the relative moisture content of the wall was 84.6% (the wall nearby was 59.7%). Water intrusion can lead to many costly problems if not corrected. Recommend further evaluation and repair as needed by a qualified licensed general contractor.

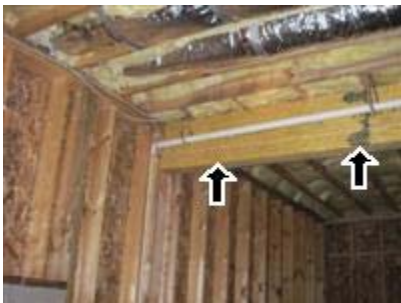
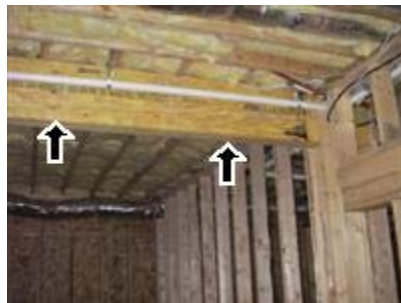
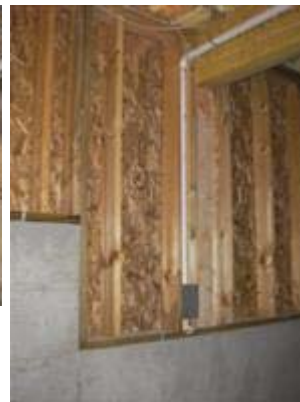
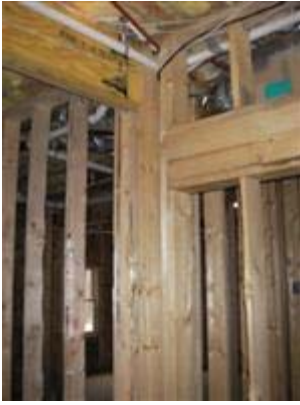
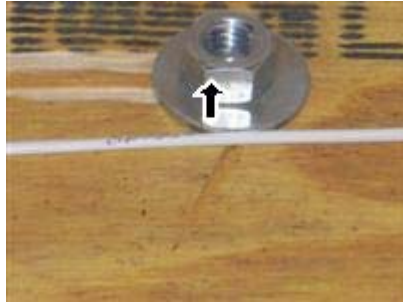
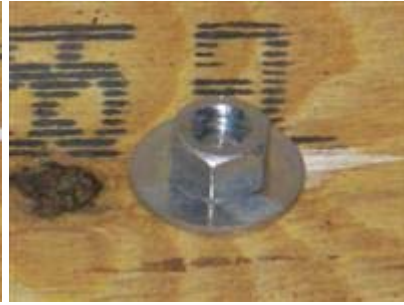
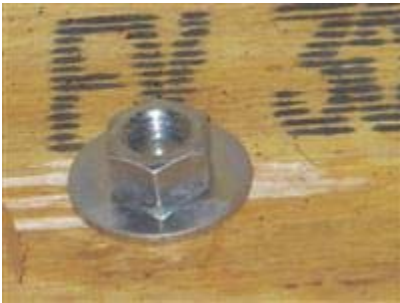
1.3 Inspected an LVL girder in the rear left section of the basement. Evidence suggests this was not part of the original plan (this is the only engineered lumber in the basement). The bolts securing the LVL beams together are barely long enough to secure the nuts in place. Recommend replacing with bolts that extend through the nuts to ensure a proper hold and finding out why the LVL was added. Recommend further evaluation and repair as needed by a qualified professional engineer.

Inspected an LVL girder in the rear left section of the basement. Evidence suggests this was not part of the original plan (this is the only engineered lumber in the basement). The bolts securing the LVL beams together are barely long enough to secure the nuts in place. Recommend replacing with bolts that extend through the nuts to ensure a proper hold and finding out why the LVL was added. Recommend further evaluation and repair as needed by a qualified professional engineer.

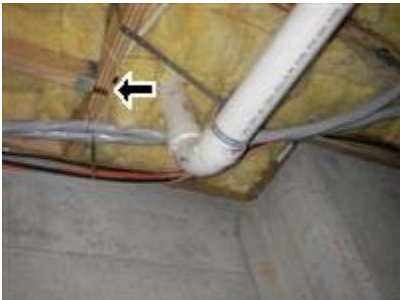
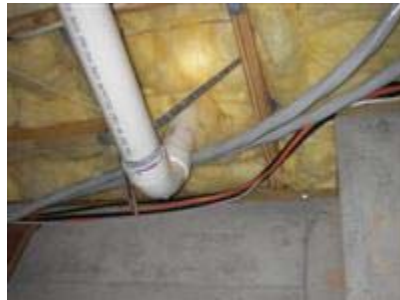
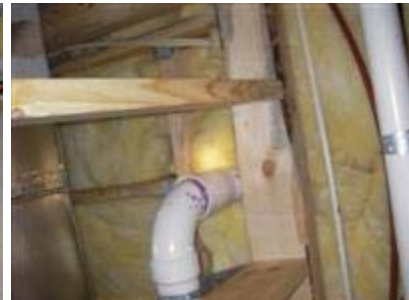
Several floor joists on the ceiling of the basement have been cut around plumbing pipes. Repairs have been made and evidence suggests they are adequate.

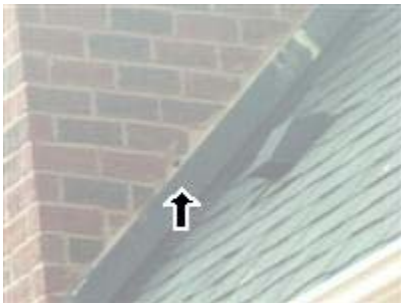
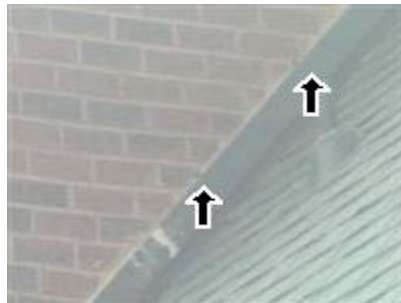
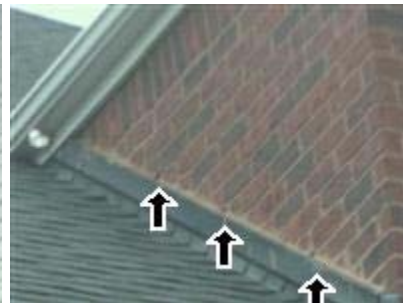
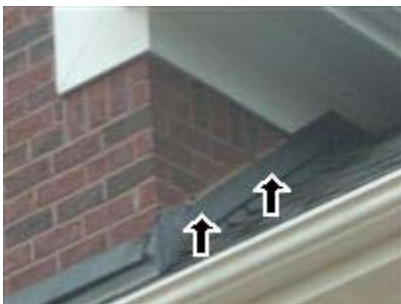
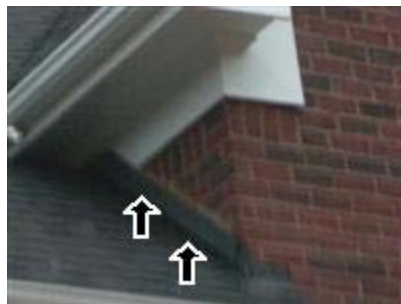
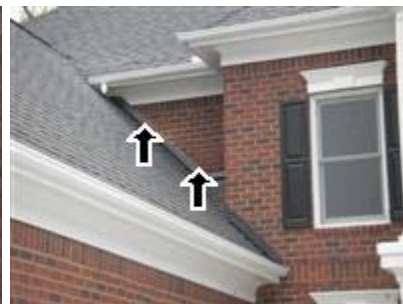
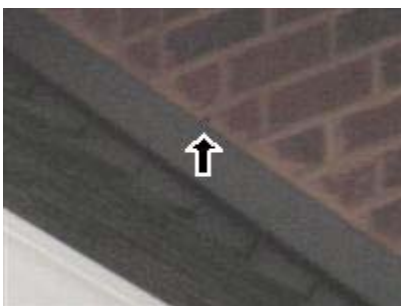
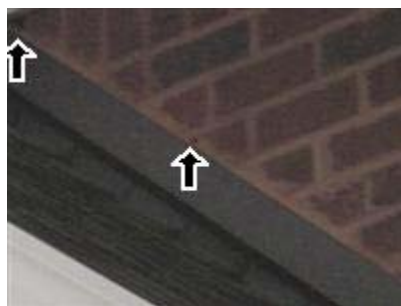
2.0 Inspected holes/voids in the mortar/brick above the angled roof flashing all around the home. They almost resemble weep holes but are not uniform in shape and are not located in areas where weep holes typically are installed. Given the amount of water that can flow along this flashing during a rain they create easy access points for water intrusion. Recommend further evaluation and repair as needed by a qualified licensed general contractor.

Inspected holes/voids in the mortar/brick above the angled roof flashing all around the home. They almost resemble weep holes but are not uniform in shape and are not located in areas where weep holes typically are installed. Given the amount of water that can flow along this flashing during a rain they create easy access points for water intrusion.

Recommend further evaluation and repair as needed by a qualified licensed general contractor.

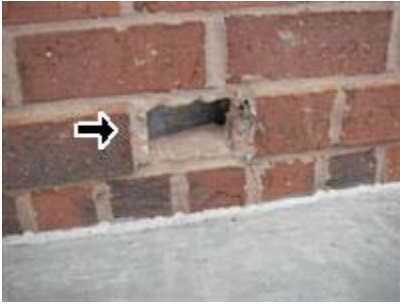
2.0 Picture 9

Inspected a hole in the brick veneer on the front of the at the second floor porch. If not corrected this is an easy area for water and pest intrusion. Evidence suggests and electrical box is to be installed in the area. Recommend further evaluation and repair as needed by a qualified licensed general contractor.

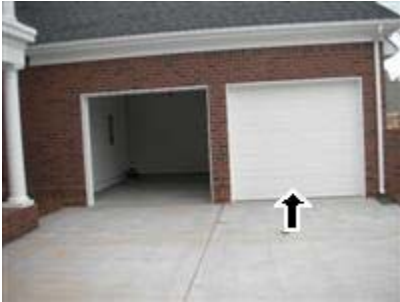
2.3 Picture 1

2.3 Garage door at right side garage nearest to the street (facing front) will not reverse when met with reasonable resistance. Doors that will not reverse when met with resistance can kill a child or pet. Recommend a qualified licensed general contractor inspect and repair as needed.

Garage door at right side garage nearest to the street (facing front) will not reverse when met with reasonable resistance. Doors that will not reverse when met with resistance can kill a child or pet. Recommend a qualified licensed general contractor inspect and repair as needed.

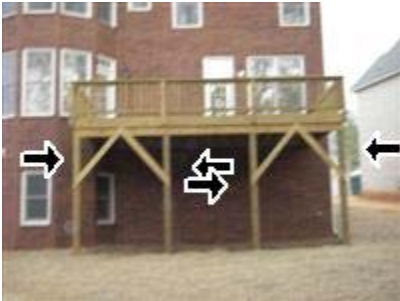
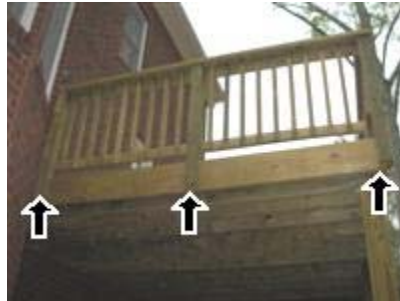
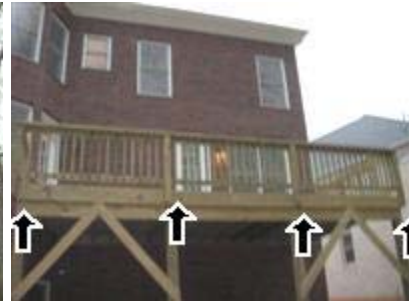
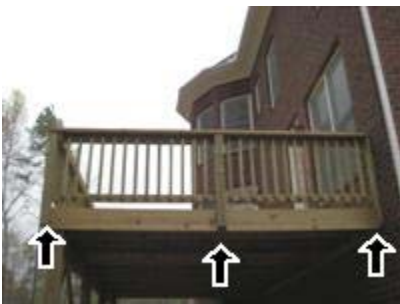
2.4 All vertical deck posts should be supported with knee braces in two directions to protect the deck from racking forces. Newel posts at the guardrail on the deck should be properly bolted to the deck ban for safety. Repairs are needed. Recommend further evaluation and repair as needed by a qualified licensed general contractor.

All vertical deck posts should be supported with knee braces in two directions to protect the deck from racking forces. Newel posts at the guardrail on the deck should be properly bolted to the deck ban for safety. Repairs are needed. Recommend further evaluation and repair as needed by a qualified licensed general contractor.

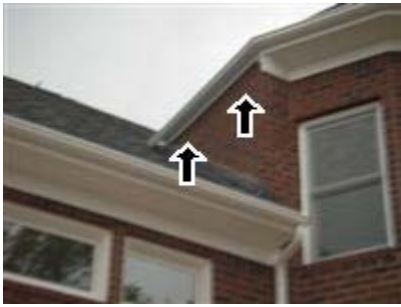
2.6 Picture 1

2.6 Evidence suggests a section of trim is missing from the eave on the rear of the home on the side of the bonus room. Repairs are advised. Recommend further evaluation and repair as needed by a qualified licensed general contractor.

Evidence suggests a section of trim is missing from the eave on the rear of the home on the side of the bonus room. Repairs are advised. Recommend further evaluation and repair as needed by a qualified licensed general contractor.

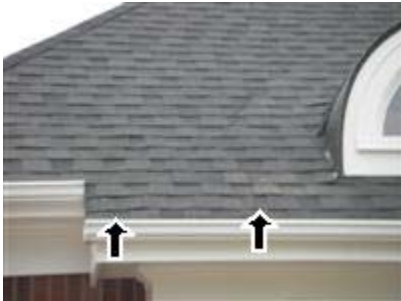
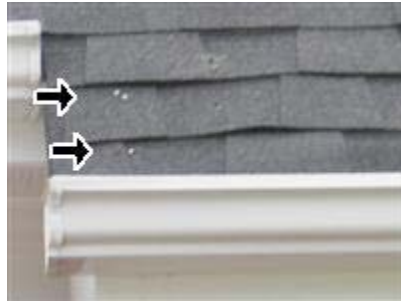
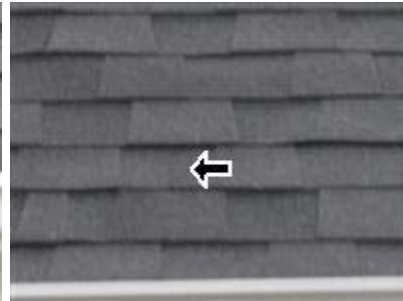
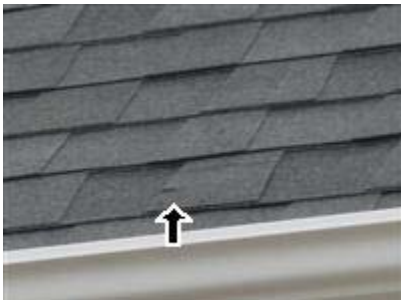
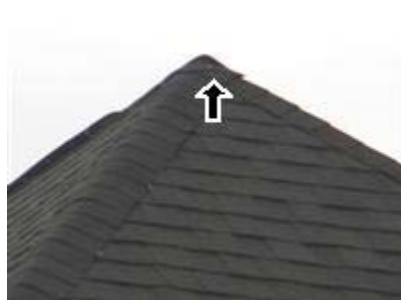
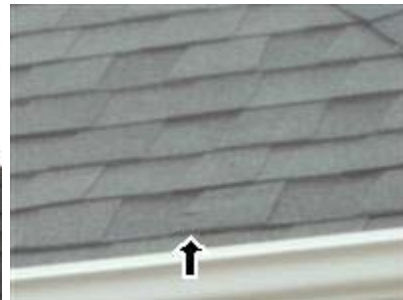
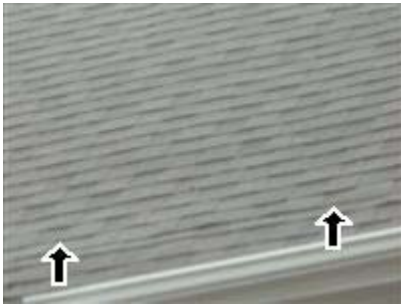
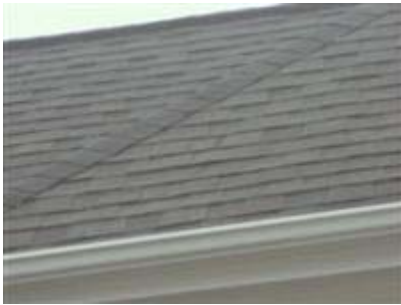
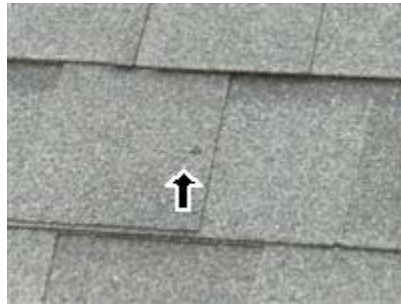
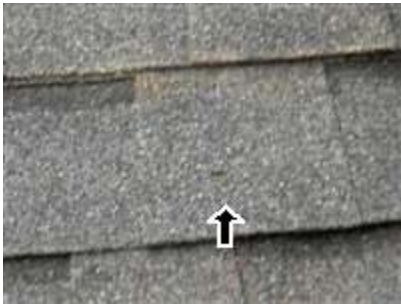
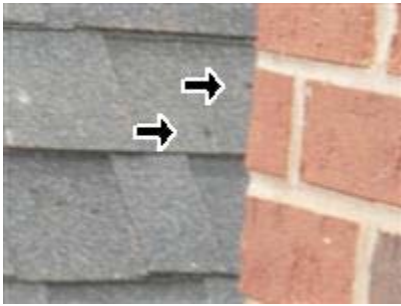
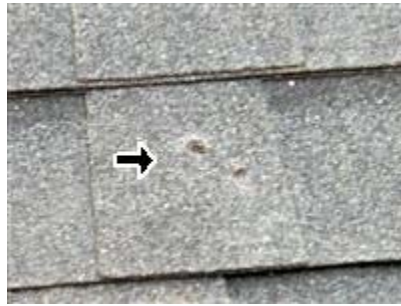
3.0 Toe board nail holes are visible in the shingles above the gutter lines around the entire roof. We can not determine if they have been repaired to prevent leaks. Recommend further evaluation and repair as needed by a qualified licensed general contractor. Visible nail heads at along the ridge lines of the roof and on the front of the home just above the gutter over the right side garage should be caulked with a roof caulk to prevent rusting and leaks. Recommend further evaluation and repair as needed by a qualified licensed general contractor.

Toe board nail holes are visible in the shingles above the gutter lines around the entire roof. We can not determine if they have been repaired to prevent leaks. Recommend further evaluation and repair as needed by a qualified licensed general contractor. Visible nail heads at along the ridge lines of the roof and on the front of the home just above the gutter over the right side garage should be caulked with a roof caulk to prevent rusting and leaks. Recommend further evaluation and repair as needed by a qualified licensed general contractor.

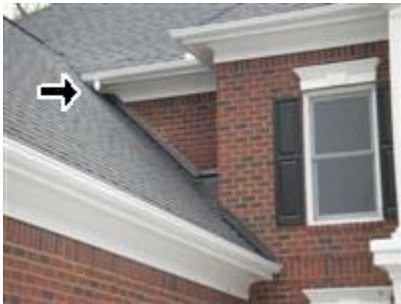
3.3 Picture 1

3.3 Recommend extending the downspout from the second story gutter above the left side garage down into the gutter below to reduce the amount of water that flows into the valley.

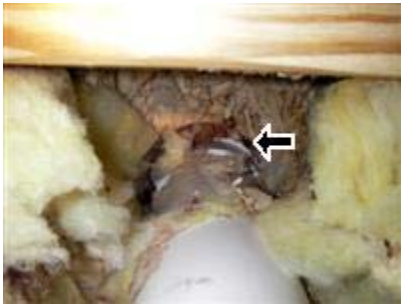
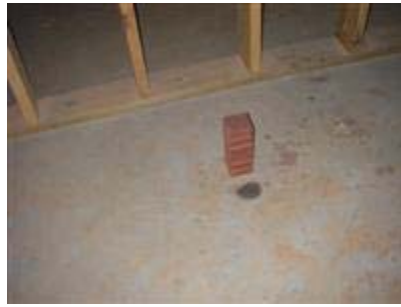
4.0 Located a drip leak under the half bath toilet. Repairs are needed. Recommend further evaluation and repair as needed by a qualified licensed plumbing contractor.

Located a drip leak under the half bath toilet. Repairs are needed. Recommend further evaluation and repair as needed by a qualified licensed plumbing contractor.

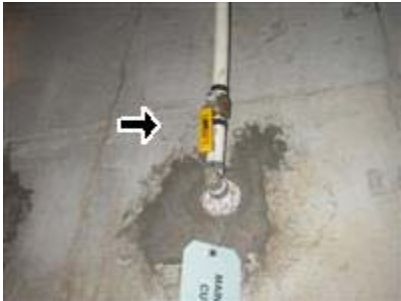
4.3 Picture 1

4.3 The main shut off is the yellow lever located in basement. This is for your information.

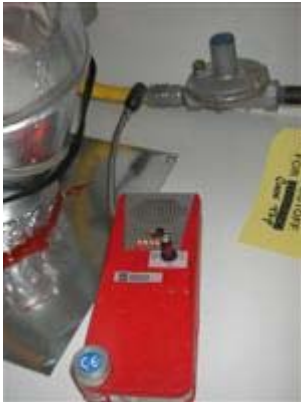
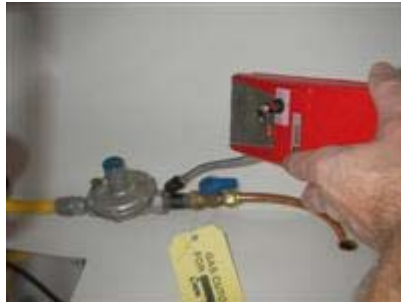
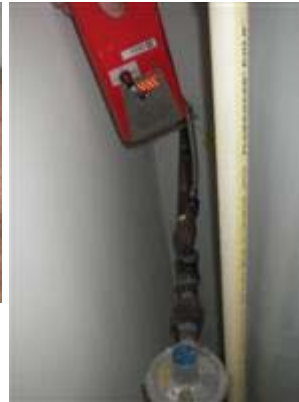
4.4 Gas Tracer (device) indicated three leaks, two under the cook top (at each side of the regulator) and at the downward elbow of the gas supply pipe to the water heater. This is a safety issue and should be repaired. Recommend a qualified professional from the gas company or licensed plumber who is certified in gas line installation and repair inspect further and repair as needed.

Gas Tracer (device) indicated three leaks, two under the cook top (at each side of the regulator) and at the downward elbow of the gas supply pipe to the water heater. This is a safety issue and should be repaired. Recommend a qualified professional from the gas company or licensed plumber who is certified in gas line installation and repair inspect further and repair as needed.

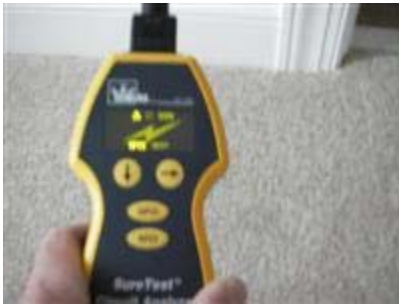
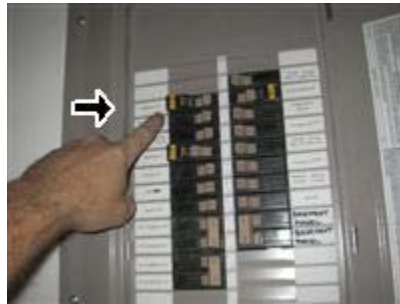
5.2 Problem(s) discovered with Branch Circuits such as ARC fault breaker for the upstairs front center bedroom (over the dining room) did not trip when tested at the outlet and any other problems that an electrician may discover while performing repairs need correcting. Recommend a licensed electrician inspect further and correct as needed.

Problem(s) discovered with Branch Circuits such as ARC fault breaker for the upstairs front center bedroom (over

the dining room) did not trip when tested at the outlet and any other problems that an electrician may discover while performing repairs need correcting. Recommend a licensed electrician inspect further and correct as needed.

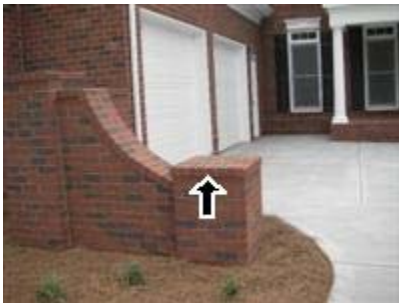
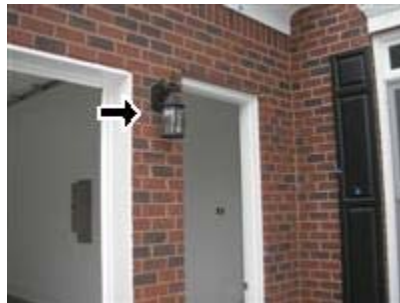
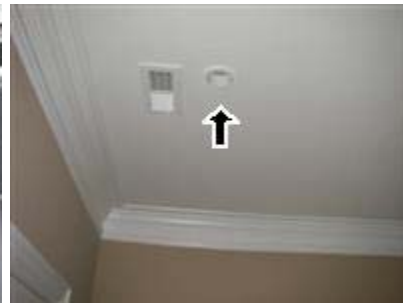
5.3 Light fixture is not installed on the exterior wall attached to the left side garage. Evidence suggests one should be there. Recommend further evaluation and repair as needed by a qualified licensed electrical contractor. Exterior light outside the left side garage did not respond to operating controls. Recommend further evaluation and repair as needed by a qualified licensed electrical contractor. Ceiling light at the cat walk to the second floor patio did not respond to operating controls. Recommend further evaluation and repair as needed by a qualified licensed electrical contractor. Light over the cooktop in the kitchen is wired into the kitchen GFCI outlets. Recommend further evaluation and repair as needed by a qualified licensed electrical contractor. Lights in the right side of the basement did not respond to operating controls. Recommend further evaluation and repair as needed by a qualified licensed electrical contractor.

Light fixture is not installed on the exterior wall attached to the left side garage. Evidence suggests one should be there. Recommend further evaluation and repair as needed by a qualified licensed electrical contractor. Exterior light outside the left side garage did not respond to operating controls. Recommend further evaluation and repair as needed by a qualified licensed electrical contractor. Ceiling light at the cat walk to the second floor patio did not respond to operating controls. Recommend further evaluation and repair as needed by a qualified licensed electrical contractor. Light over the cooktop in the kitchen is wired into the kitchen GFCI outlets. Recommend further evaluation and repair as needed by a qualified licensed electrical contractor. Lights in the right side of the basement did not respond to operating controls. Recommend further evaluation and repair as needed by a qualified licensed electrical contractor.

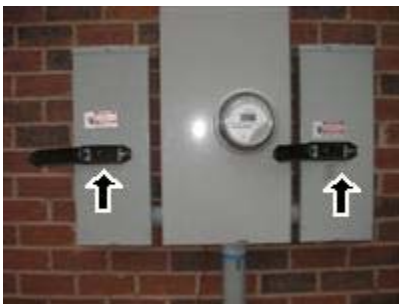
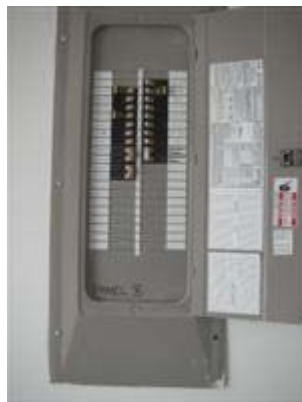
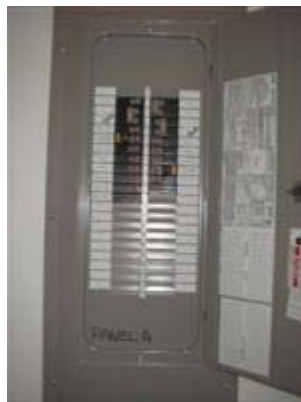
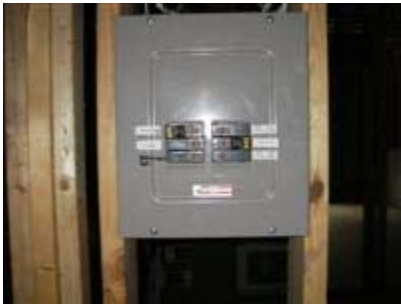
5.6 Main panel box is located at garage(s). However, main disconnect (shut-off) is outside at meter base panel (for your information). Sub panel box is located at basement and outside.

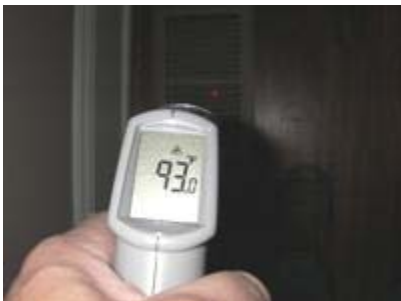
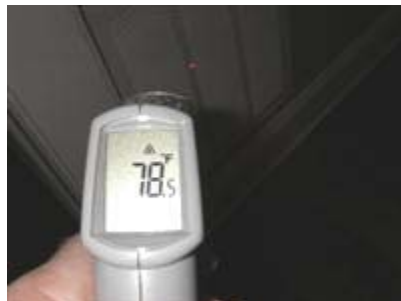
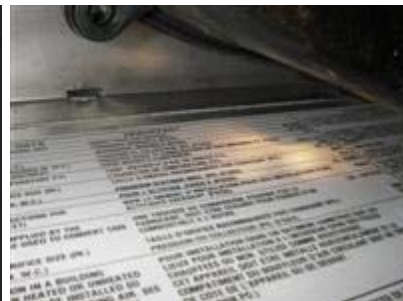
6.0 Temperature differential of the heating system was measured by using a laser thermometer to determine the difference of the supply and return temperatures. The main floor supply did not exceed 93 degrees and the main floor return was 78 degrees. The panel inside the furnace indicates that the temperature rise should be between 30-60 degrees. A possible reason for the problem could include an undersized furnace for the square feet serviced; the first floor unit is significantly smaller (88,000 BTU) than the second floor unit (110,000 BTU) and evidence suggests the first floor has more square feet than the second floor. Recommend further evaluation and repair as needed by a qualified licensed HVAC contractor.

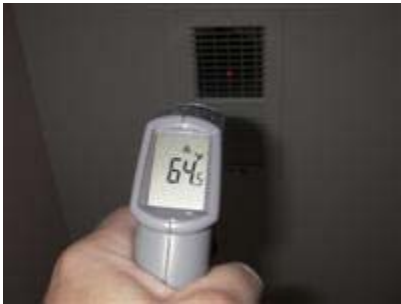
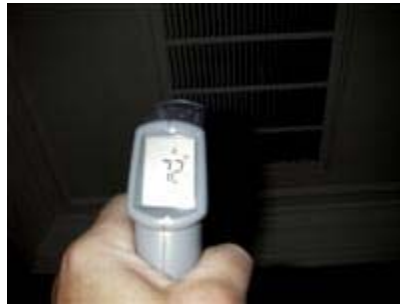
7.0 Ambient air test was performed by using laser thermometers Air conditioner to determine if the difference in temperatures of the supply and return air are between 14 degrees and 22 degrees which indicates unit is cooling as intended. The supply air temperature on your system read 64 degrees, and the return air temperature was 72 degrees. This indicates that the upper level unit not cooling properly and a licensed Heat/Air contractor should inspect for cause or problem.

Ambient air test was performed by using laser thermometers Air conditioner to determine if the difference in temperatures of the supply and return air are between 14 degrees and 22 degrees which indicates unit is cooling as intended. The supply air temperature on your system read 64 degrees, and the return air temperature was 72 degrees. This indicates that the upper level unit not cooling properly and a licensed Heat/Air contractor should inspect for cause or problem.

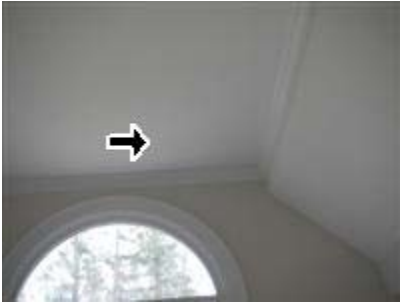
8.0 Picture 1

8.0 Inspected a stain on the ceiling in the master bathroom. The insulation above this area in the attic was wet at the time of the inspection. Evidence suggests there is a leak in the area. Recommend further evaluation and repair as needed by a qualified licensed general contractor.

Inspected a stain on the ceiling in the master bathroom. The insulation above this area in the attic was wet at the time of the inspection. Evidence suggests there is a leak in the area. Recommend further evaluation and repair as needed by a qualified licensed general contractor.

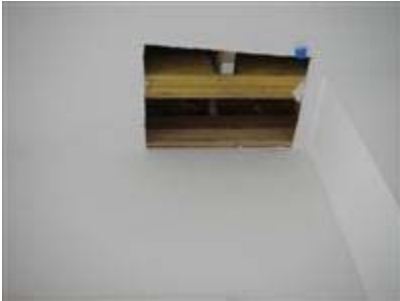
8.0 Picture 2

A section of sheetrock was removed from the left side garage ceiling. This should be repaired to provide a proper fire barrier separation. Recommend obtaining information on why it was removed and further evaluation and repair as needed by a qualified licensed general contractor.

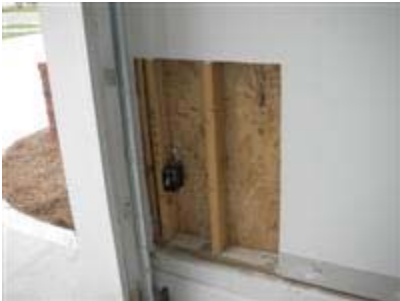
8.1 Picture 1

8.1 A section of sheetrock was removed from the left side garage wall. Recommend obtaining information on why it was removed and further evaluation and repair as needed by a qualified licensed general contractor.

A section of sheetrock was removed from the left side garage wall. Recommend obtaining information on why it was removed and further evaluation and repair as needed by a qualified licensed general contractor.

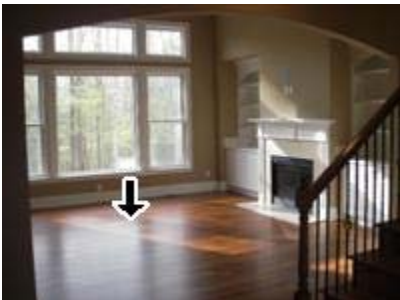
8.2 Picture 1

8.2 Floor in the den bounces more than the rest of the home during heel drop tests. The floor system in the area is made up of 2" by 10" joists, spaced 12" on center and spanning approximately 17'; this basically represents the maximum allowable span. The addition of furniture etc. will likely increase the bounce of the floor and may lead to owner concerns with the integrity of the floor system. Recommend further evaluation and repair as needed by a qualified licensed general contractor.

up of 2" by 10" joists, spaced 12" on center and spanning approximately 17'; this basically represents the maximum allowable span. The addition of furniture etc. will likely increase the bounce of the floor and may lead to owner concerns with the integrity of the floor system. Recommend further evaluation and repair as needed by a qualified licensed general contractor.
