Inspection Report

Two Year Old Home Sample Comparison Inspection

Two Year Old 4,000+ Sq Ft Home
Comparison Inspection
Any City, NC

King Construction, Inc dba Inspector Paul

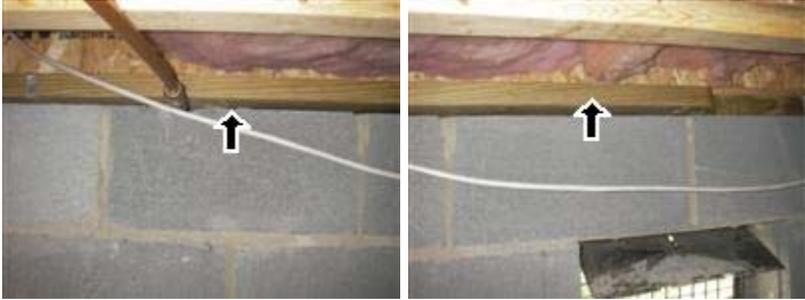
1.1 Picture 1

1.1 Mud sill on the far left side of the home is being pushed upward and twisted due to a gas line being installed between the CMU block wall and mudsill. Recommend further evaluation and repair as needed by a qualified licensed general contractor.

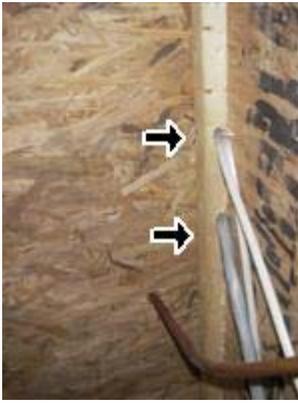
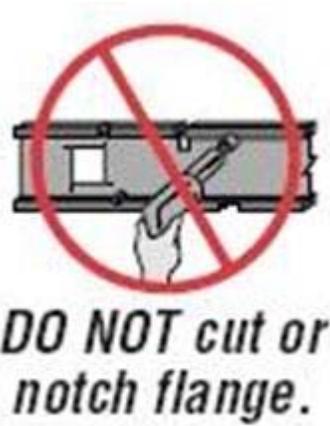
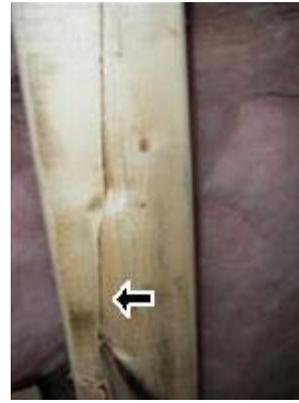
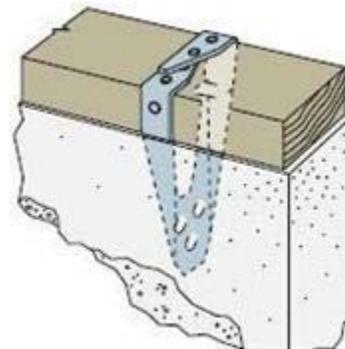
(2) The top flange of the engineered floor joist under the cooktop has been damaged by a tradesman. The bottom flange of both engineered trusses at each inside corner where the garage and dining room meet are cracked. Repairs are needed. Recommend further evaluation and repair as needed by a qualified licensed representative from the truss manufacturer or a professional engineer. The two mudsill straps in the outside corner under where the garage and and dining room meet are not nailed in place. Repairs are needed. Recommend further evaluation and repair as needed by a qualified licensed general contractor.

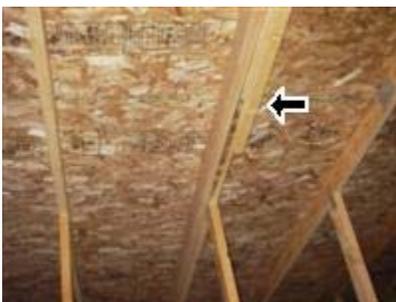
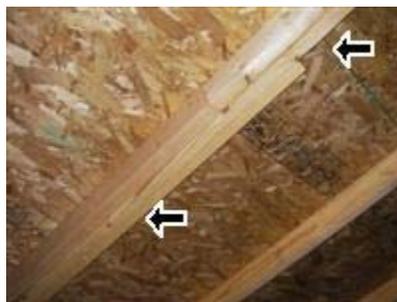
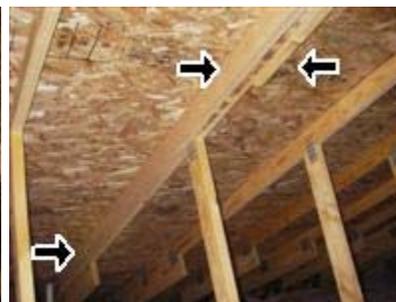
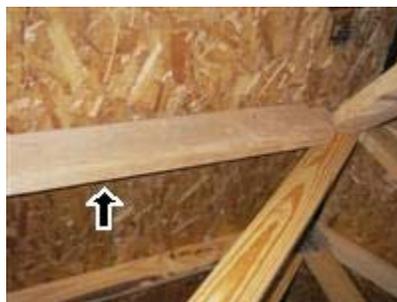
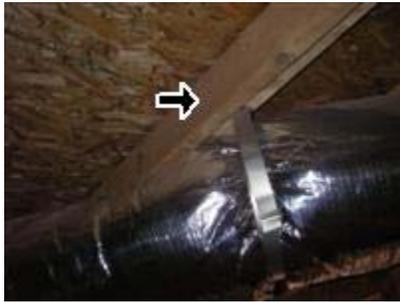
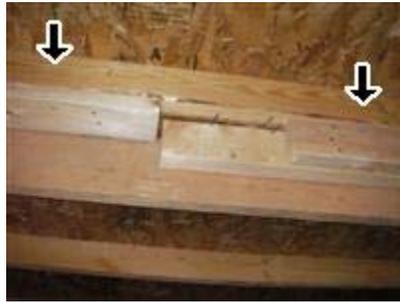
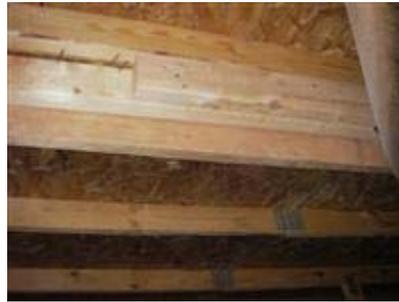
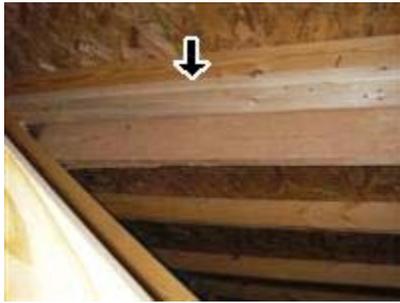
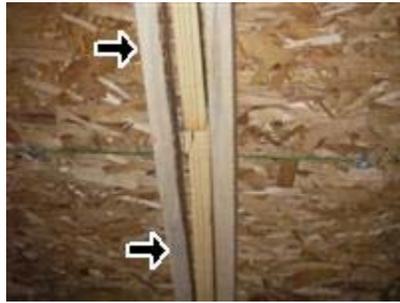
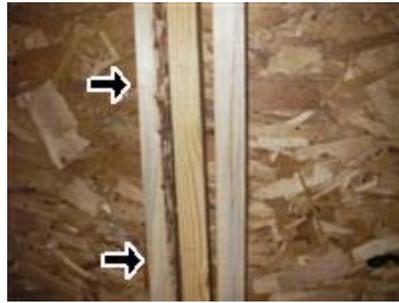
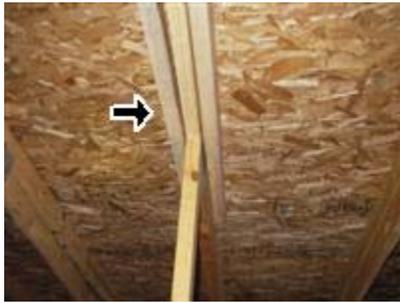
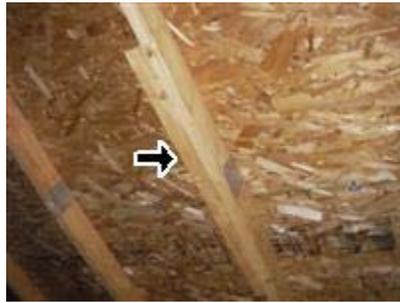
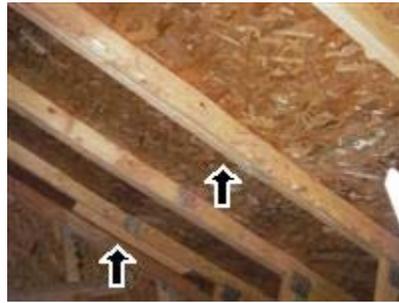
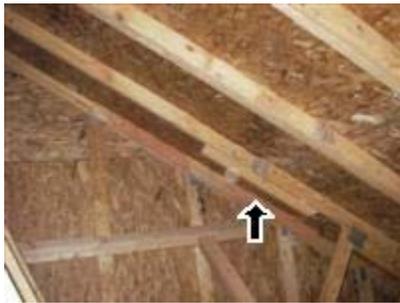
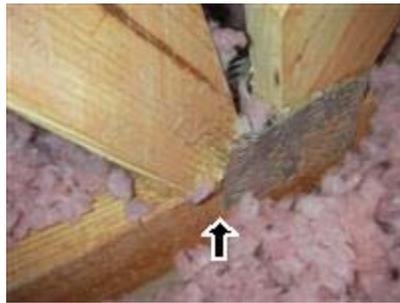
1.5 (1) Several of the engineered trusses in the visible/accessible areas of the attic were damaged and/or had some level or repairs performed. None of the repairs were typical of engineered design and or performed in a manner that many construction professionals would consider workmanlike. We will attempt to identify all of the issues, but we strongly recommend that the entire roof structure and attic be inspected by a qualified professional engineer, repaired per their designs, and re evaluated after repairs by the engineer to assure his/her plans were followed. Damaged and altered trusses include top chord of the truss directly behind the pull down stairs, the third truss to the left of the pull down stairs on the front of the home (where the roof line changes slightly) has a combination of studs and OSB sheathing screwed to the side of the stud to accommodate the change in the roof line, several trusses on the rear of the home including the 4th truss to the left of the end of the attic flooring and others along the way to the left side wall, and a web on the 6th truss over from the left side of the home is twisted and separating from the bottom truss plate. Recommend further evaluation and repair as needed by a qualified technical representative from the truss manufacturer or a qualified professional engineer.

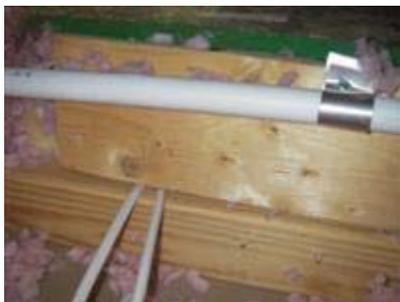
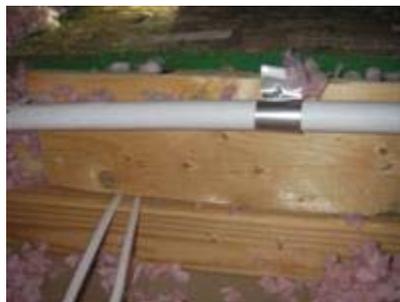
(2) The platform for the HVAC system was built on site. Studs were laid on top of the bottom chords of the truss system and nailed in place. Any alteration, modification, or repair to an engineered truss system needs to be designed and approved by a technical representative from the truss manufacturer or a professional engineer. Recommend further evaluation and repair as needed by a qualified technical representative from the truss manufacturer or a qualified licensed professional engineer.

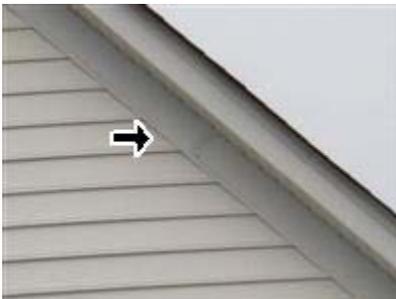
2.0 Picture 1

2.0 Metal fascia wrap on the front of the home above the master bedroom is poorly seamed together. Repairs are advised to reduce water intrusion. Recommend further evaluation and repair as needed by a qualified licensed general contractor.

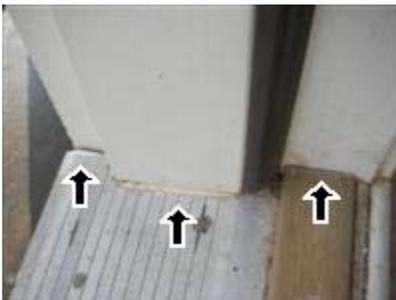
2.1 Picture 1

2.1 Exterior doors do not have corner seal pads installed and are not caulked where the frame meets the threshold. Door manufacturers require this to prevent water intrusion and deterioration of the frame. Recommend further evaluation and repair as needed by a qualified licensed general contractor.

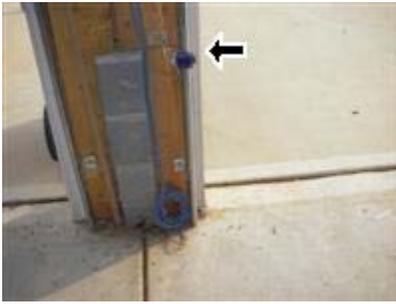
2.3 Picture 1

2.3 (1) Garage door at right side (facing front) has electronic sensors located higher than six inches off floor which may not be installed according to manufacturers specification. This is considered unsafe and needs correcting. Recommend a qualified licensed general contractor inspect and repair as needed.

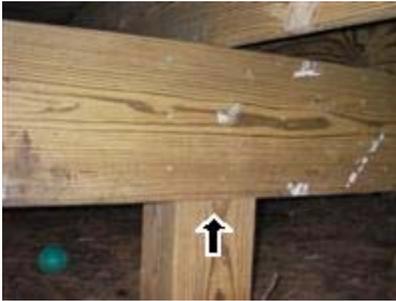
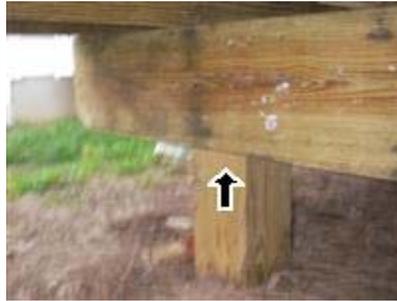
2.4 (1) Recommend securing the drop girder to the vertical posts at the deck with carriage bolts. The deck risers were secured at the top with nails instead of slopeable joist hangers. Recommend further evaluation and repair as needed by a qualified licensed general contractor.

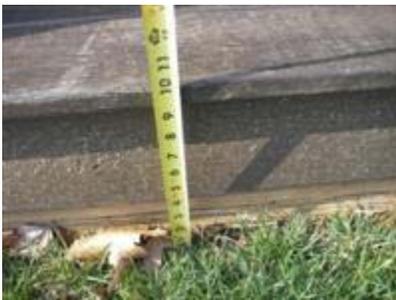
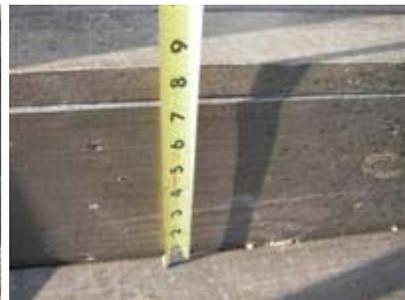
(2) Risers at the right side door steps range in height from approximately 6+\" to 10\". Stair risers should not be more than 8\" tall and the maximum differential between risers should not exceed 3/8\". The deck risers were secured at the top with nails (substandard). Failure to correct could cause a fall or injury. Recommend further evaluation and repair as needed by a qualified licensed general contractor.

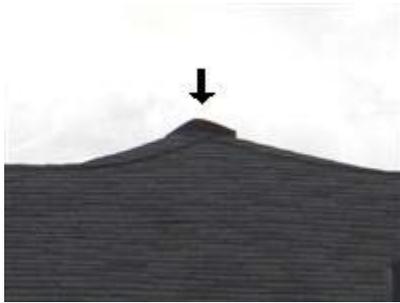
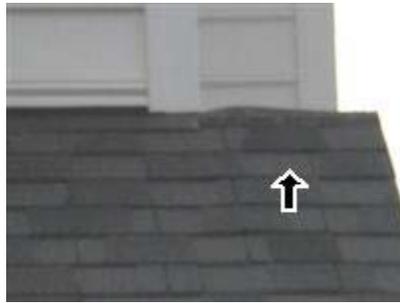
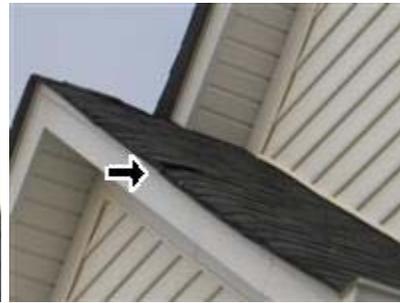
3.0 Corner shingle where the two gable roofs intersect over the master bedroom/bathroom is not secured down on the rear side of the home. A shingle is missing on the rear of the home at the first floor shed roof nearest the right side of the home (outside the den). Shingle on the right side of the small gable

roof on the front of the home outside the master bathroom is raised upward. Leaks can develop if not corrected. Recommend further evaluation and repair as needed by a qualified licensed general contractor.

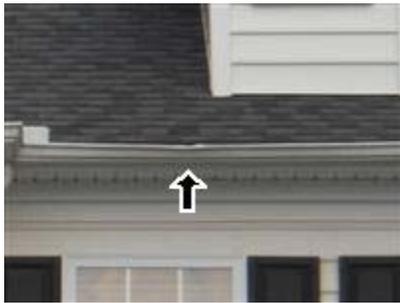
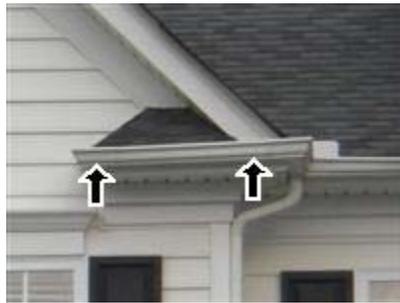
3.3 Downspouts should be extended at least 6' away from the home to keep water away from the foundation. Gutter at the second floor roof line above the covered porch has some minor damage. Gutter at the second floor roof line above the covered porch is not sloped towards the downspout. Repairs are advised. Recommend further evaluation and repair as needed by a qualified licensed general contractor.

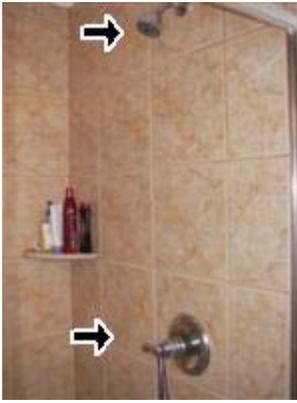
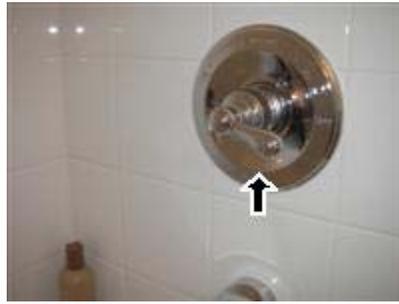
4.1 Turning the control knob at the master bath shower to 9:00/marked hot turns off the water supply to the shower. Control knob is the private bath is installed incorrectly, down is off, off is hot, and the knob does not complete more than 1/4 turn (instead of 1/2 turn). Recommend further evaluation and repair as needed by a qualified licensed plumbing contractor.

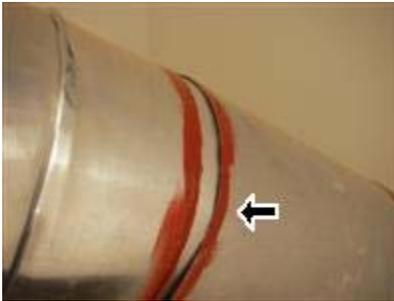
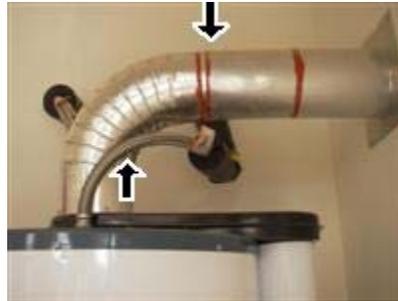
4.2 Water heater flue pipe has separated at the seams. Repairs are needed for safety. We could not locate a thermal expansion tank attached to the cold water line in front of the water heater. This is typically required to prevent excessive pressures from being exerted on the water heater tank. A full article on the subject is available at http://www.pahi.org/plumbing_information.html Recommend further evaluation and repair as needed by a qualified licensed plumbing contractor.

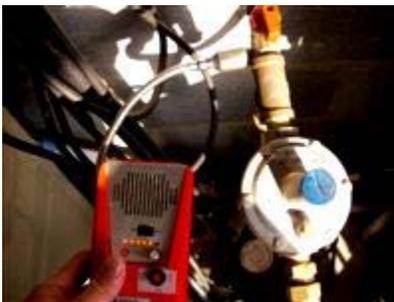
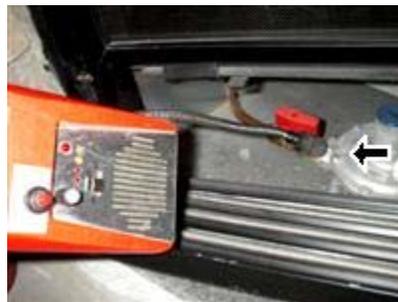
4.4 Gas Tracer (device) indicated leaks exist beside the red on/off valve at the water heater and between the red on/of valve and regulator at the gas logs. This is a safety issue and should be repaired. Recommend a qualified professional from the gas company or licensed plumber who is certified in gas line installation and repair inspect further and repair as needed.

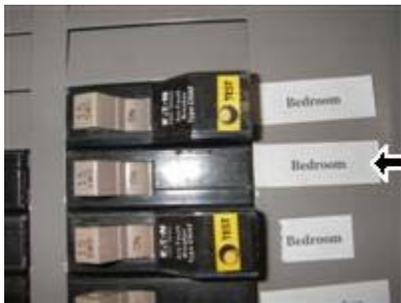
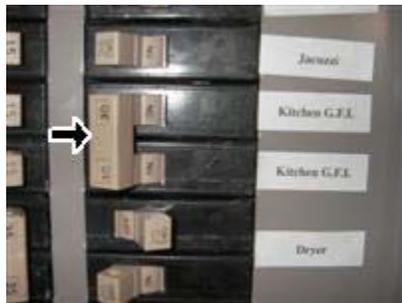
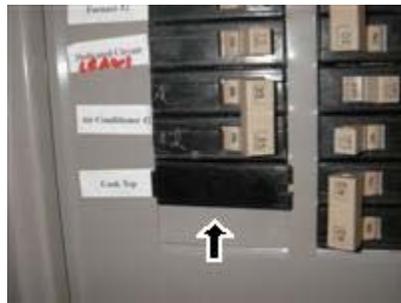
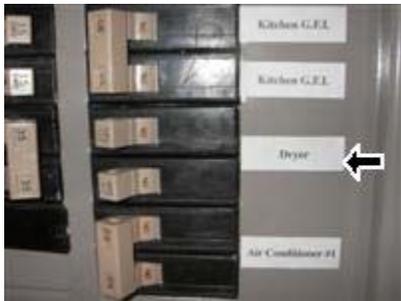
5.1 Problem(s) discovered in panel such as breakers are poorly/improperly marked (breaker marked bedroom is not an ARC fault breaker and does not power a bedroom, breaker marked kitchen GFI is a double pole 30 amp breaker, two 20 amp breakers are marked dryer, slot marked cooktop has no breaker) and any other problems that an electrician may discover while performing repairs need correcting. Recommend a licensed electrician inspect further and correct as needed.

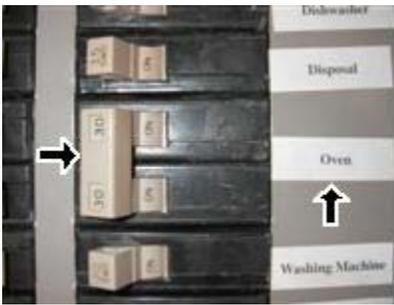
5.2 Picture 1

Circuit breakers marked "oven" is smaller than 40 amps. National Electric Code (NEC) 210-19c states " Branch circuit conductors supplying household ranges, wall mounted ovens, counter mounted cooking units, and other household cooking appliances shall have an ampacity not less than the rating of the branch circuit and not less than the maximum load to be served. For ranges of 8 3/4 kW or more rating, the minimum branch-circuit rating shall be 40 amperes." Recommend further evaluation and repair as needed by a qualified licensed electrical contractor.

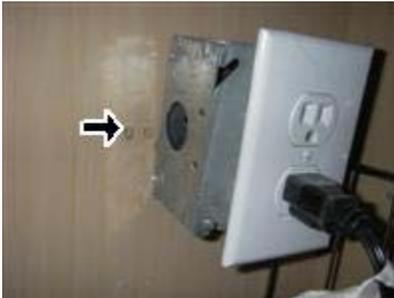
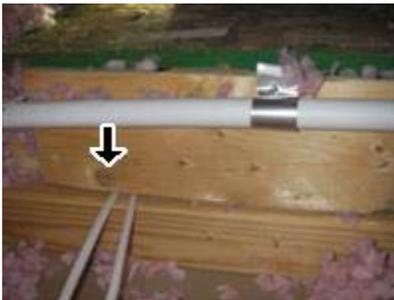
5.3 Most of the exterior lights did not respond to operating controls (possible burnt out bulb). Junction box in the kitchen cabinet under the cooktop is missing a knockout. Wall light fixture in the half bath has exposed electrical wiring that is getting pinched between the fixture and wall. Receptacle on the mirror in the master bath is loose against the wall. Electrical wiring was run between the studs of the HVAC platform in the attic and are being pinched by the studs. Electrical issues should be considered hazardous and repaired. Recommend further evaluation and repair as needed by a qualified licensed electrical contractor.

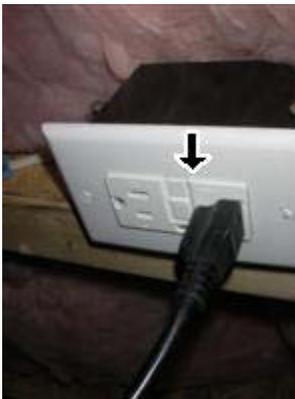
5.5 Picture 1

5.5 GFCI receptacle in front of the crawlspace furnace is tripped and will not reset. This leaves the condensate drain pump with no power. Repairs are needed. Recommend further evaluation and repair as needed by a qualified licensed electrical contractor.

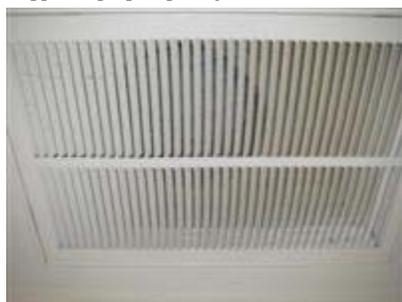
6.5 Picture 1

6.5 Return just outside the bonus room door had not filter, filters are required to keep the furnace clean. Recommend cleaning, further evaluation and repair as needed by a qualified licensed HVAC contractor. Sections of ductwork in the left side of the crawlspace are lying on the ground and not strapped at proper spacing. Recommend cleaning, further evaluation and repair as needed by a qualified licensed HVAC contractor.

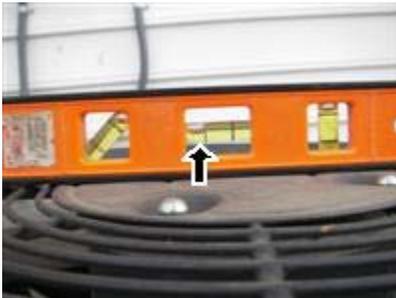
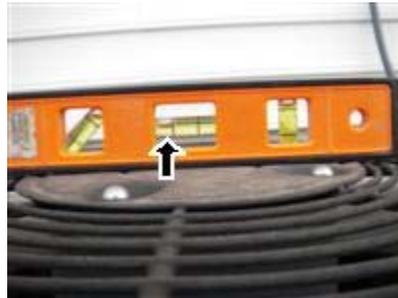
7.0 Platform for the compressors are not level. This does not allow proper oil distribution in the motor and can lead to damage. Repairs are advised. Recommend service or repair unit using a qualified licensed HVAC contractor.

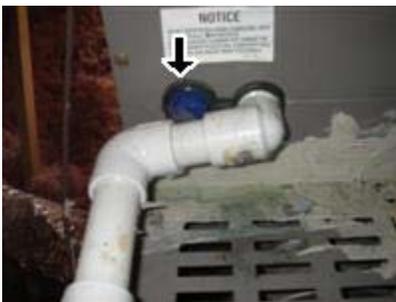
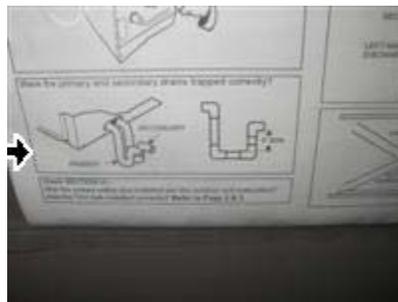
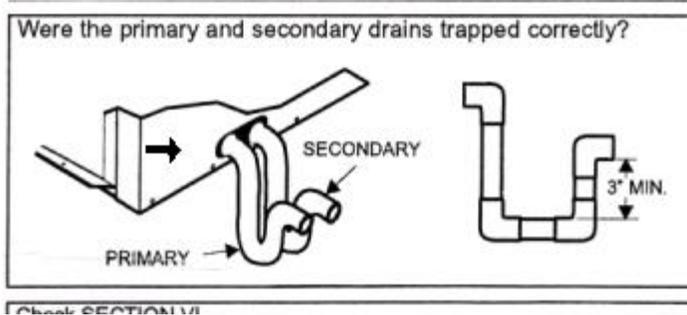
7.2 (1) Secondary overflow drain connection is not installed in both furnaces. The manufacturer's instruction sheet was in a packing slip on the side of the air handler with the diagram stating the need to install the secondary overflow connections and require proper installation to prevent an overflow at the air handler dripping onto the live electrical components below and damaging the furnace. Recommend further evaluation and repair as needed by a qualified licensed HVAC contractor.

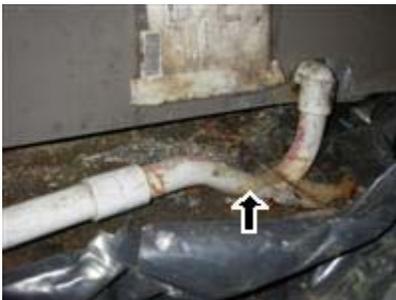
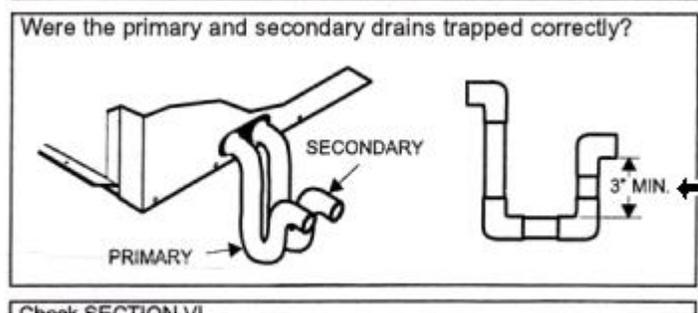
(3) Condensation line in the crawlspace has a running trap installed instead of a P trap. Recommend a qualified licensed HVAC (Heat/Ventilation/Air conditioning Contractor) inspect further and repair as needed.

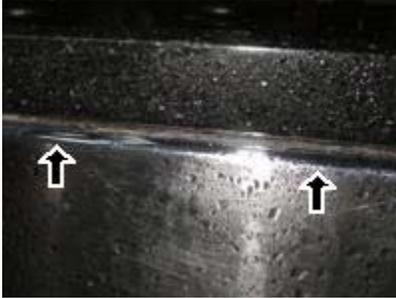
8.4 Picture 1

8.4 Seam between the counter top and sink should be properly caulked to prevent a concealed fouling area. Recommend further evaluation and repair as needed by a qualified licensed general contractor.

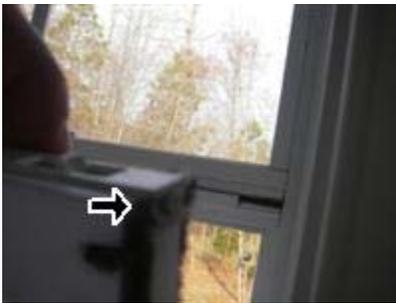
8.6 Picture 1

8.6 The tilt in pin that secures the the bottom sash of the window is broken along the right side of the first floor window on the rear of the home nearest the driveway. Recommend further evaluation and repair as needed by a qualified licensed general contractor.

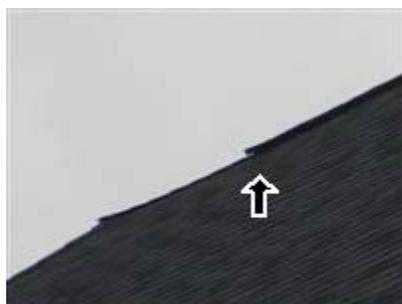
9.1 Picture 1

9.1 (1) Rear corner of the ridge vent over the master bedroom/master bathroom area is pulling away from the roof coverings. Repairs are needed to prevent leaks and keep the ridge vent from getting pulled off of the roof. Recommend further evaluation and repair as needed by a qualified licensed general contractor.

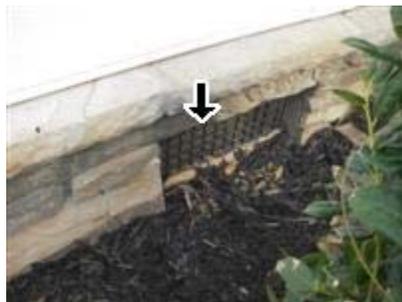
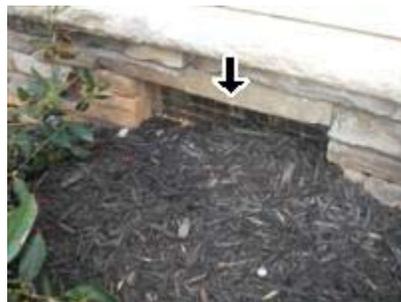
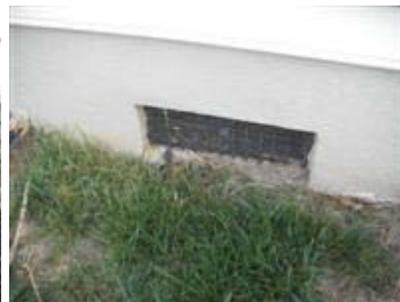
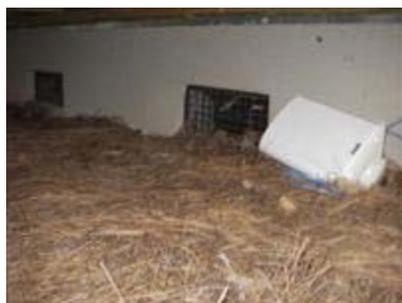
(2) Foundation vents are at and below ground level at the front, rear and left sides of home which can allow water to enter crawlspace. Half-round window wells should be installed. The dirt inside well should be replaced with approximately four inches of gravel. A couple of inches clearance between gravel and vent opening recommended. Recommend further evaluation and repair as needed by a qualified licensed general contractor.
