Inspection Report

Two Year Old Home Sample Comparison Inspection

Two Year Old 4,000+ Sq Ft Home
Comparison Inspection
Any City, NC

King Construction, Inc dba Inspector Paul

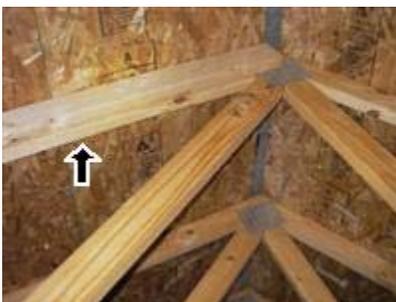
1.5 Picture 4

1.5 (1) Several of the engineered trusses in the visible/accessible areas of the attic were damaged and/or had some level or repairs performed. None of the repairs were typical of engineered design and or performed in a manner that many construction professionals would consider workmanlike. We will attempt to identify all of the issues, but we strongly recommend that the entire roof structure and attic be inspected by a qualified professional engineer, repaired per their designs, and re evaluated after repairs by the engineer to assure his/her plans were followed. Damaged and altered trusses include top chord of the truss directly behind the pull down stairs, the third truss to the left of the pull down stairs on the front of the home (where the roof line changes slightly) has a combination of studs and OSB sheathing screwed to the side of the stud to accommodate the change in the roof line, several trusses on the rear of the home including the 4th truss to the left of the end of the attic flooring and others along the way to the left side wall, and a web on the 6th truss over from the left side of the home is twisted and separating from the bottom truss plate. Recommend further evaluation and repair as needed by a qualified technical representative from the truss manufacturer or a qualified professional engineer.

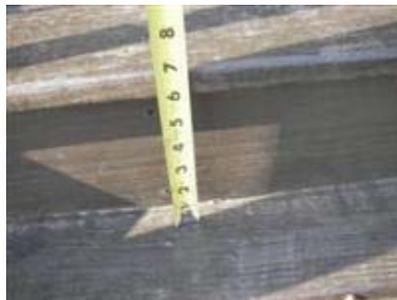
2.4 Picture 4

(2) Risers at the right side door steps range in height from approximately 6+\" to 10\". Stair risers should not be more than 8\" tall and the maximum differential between risers should not exceed 3/8\". The deck risers were secured at the top with nails (substandard). Failure to correct could cause a fall or injury. Recommend further evaluation and repair as needed by a qualified licensed general contractor.

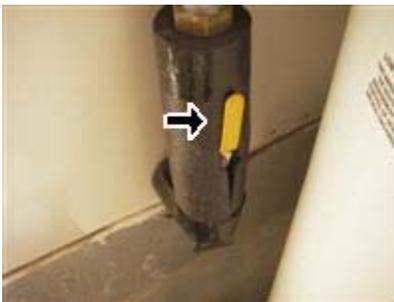
4.3 Picture 1

4.3 The main shut off is the yellow lever located in garage. This is for your information.

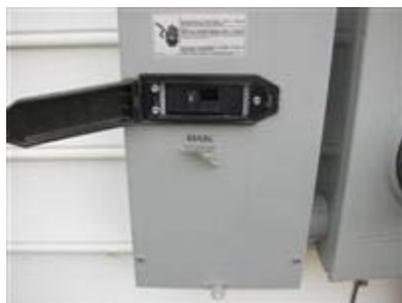
5.6 Picture 1

5.6 Main panel box is located at garage. However, main disconnect (shut-off) is outside at meter base panel (for your information).

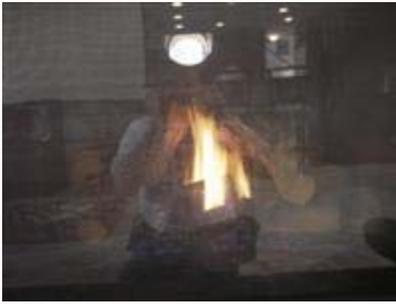
6.6 Picture 1

6.6 Logs functioned at the time of the inspection.
